# ACCURATE BRAZING

AN INDEPENDENT STUDY

## Can HIP'ing Restore And Strengthen Mechanical Properties Of Engine Run Gas Turbine Components, And Components Produced By Additive Manufacturing.

BY WARREN MIGLIETTI, PH.D., MAY, 2020

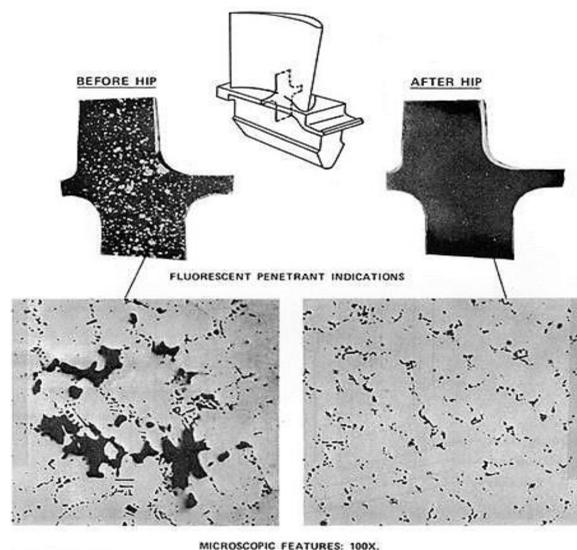
**Figure 1: Collapse of microporosity as a result of the HIP (Hot Isostatic Press) process/technology**

**Figure 1** shows a microstructure (left hand side) of an investment cast component exhibiting high or unacceptable porosity and the same figure shows a microstructure (right hand side) of the absence/collapse of the micro pores as a result of the HIP'ing process, which is performed at high temperatures (e.g. 2150—2250°F) at high argon pressures of 15ksi – 25ksi and for 2 – 4 hours for Nickel base superalloy material. — continued on page 2

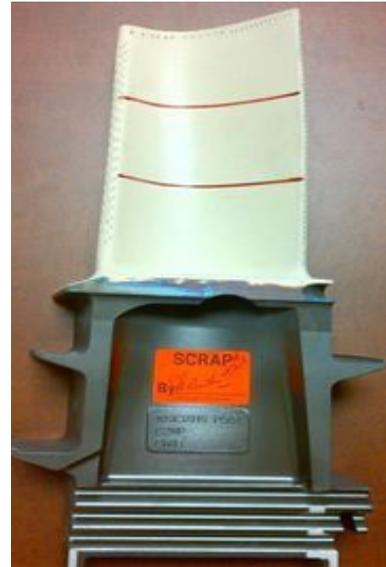
**Figure 2: Scrapped Fr7FA.03, stage 1 bucket after 3 engine service (hot gas path) intervals**

**Figure 2** below shows a scrapped engine run Fr7FA.03, stage 1 bucket. There are 92 of these 1st stage buckets in an engine set. Based on careful evaluation, a minimum of the worst 2 are removed from the engine test for metallurgical and destructive testing, the latter involving tensile testing and stress rupture testing of the engine run material.

The airfoil of the bucket is divided into 3 equal areas as shown in **figure 2**, at approximately 33% span, 66% span and removed at the platform fillet region.

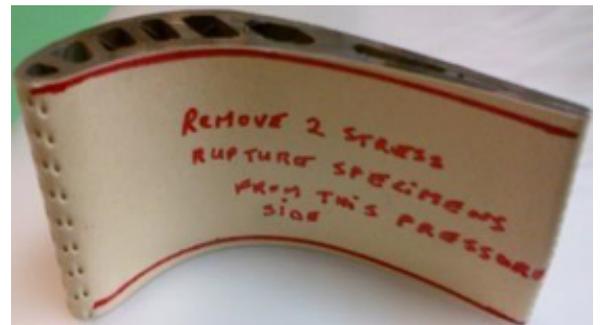
**Figure 3: Section of the airfoil removed by water-jet cutting for destructive analysis**

Once the section of airfoil materials are removed as shown in **figure 3**, the goal is to try remove/excise a minimum of 2 specimens from the pressure side/concave side of the airfoil. The pressure side of the airfoil is the side where the writing is shown in **figure 3**. The back wall is the suction side, also referred to as the convex side. A minimum of 2 specimens are also removed from the suction side wall of the scrapped bucket.

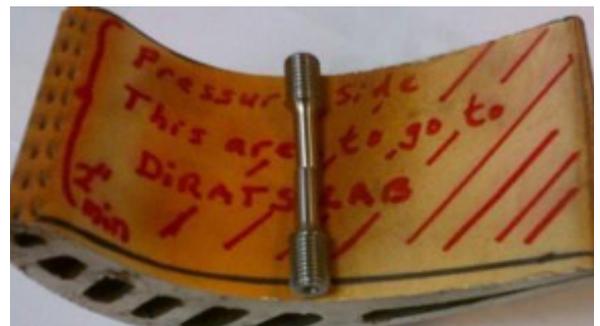
**Figure 4: Schematic of removing tensile and stress rupture specimen from the airfoils.**

Once the section of airfoil is removed, one can send the material to approved NADCAP or ISO certified laboratories throughout the United States, or if one has an in-house laboratory, the machining of sub-size tensile and stress rupture specimens can be performed as shown schematically in **figure 4**. Not only are samples removed from the airfoil, which see high temperature exposure and high levels of stress/strain, samples are also removed from the root of the blade, which are not exposed to high temperature and have minimal microstructure degradation. — continued on page 4

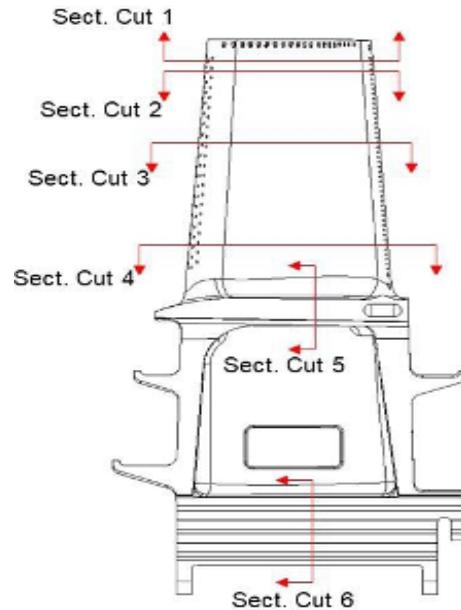
**Figure 5: Schematic plan of where a blade/bucket may be sectioned to perform either metallurgical evaluations or mechanical property evaluations.**

Other sections of the bucket/blade may be cut up as shown schematically in **figure 5**, to perform metallurgical evaluations of the base metal on the optical or scanning electron microscopes.

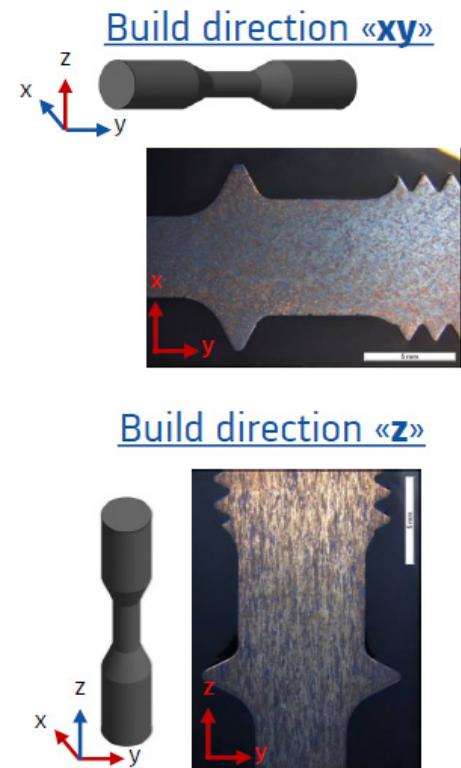
**Figure 6: Tensile specimens produced in different orientations by the laser powder bed fusion AM process.**

For the Additive Manufactured (AM) tensile specimen/samples, they were produced by the laser powder bed fusion process as schematically shown in **figure 6**, and thereafter the specimens were subjected to different heat treatments inclusive of the HIP'ing process. Thereafter tensile tests were undertaken as per the ASTM E8 specification and the results reported in each case study.
